APPLICATIONS OF TEXTURED SURFACES TO HYDRAULIC SYSTEM COMPONENTS: A REVIEW

Abstract: *This paper presents an analysis of how micro-textures created on the surfaces of various hydraulic components influence friction, wear, lubrication and energy efficiency. The first part describes the main causes of failure of hydraulic components, such as abrasion, corrosion, material fatigue and wear of sealing elements. Subsequently, recent results from the specialized literature on the performance of textured components are synthesized, including experimental studies and numerical models that highlight the role of micro-cavities in capturing wear particles, maintaining the lubricating film and reducing the friction coefficient.*

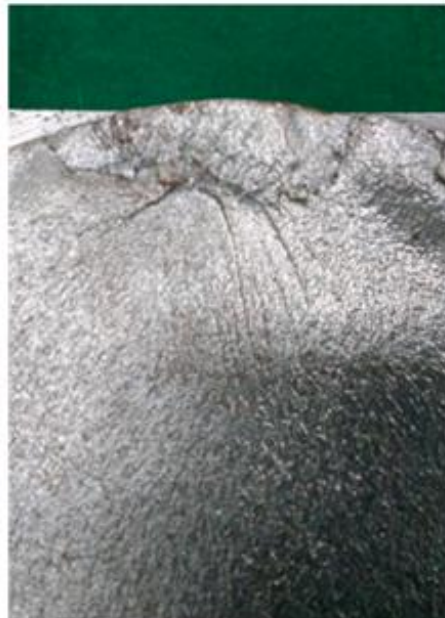
Piston rods are the elements that fail most often, as they are subject to high tensile and compressive stresses, but also to external factors such as temperature changes, precipitation, dust and dirt. In their work, Moreira D. et al. analysed the causes of failure of the piston rod of a hydraulic cylinder used to move a weir. The material used to make the piston rod was stainless steel. The results of the analysis showed that the crack (Fig. 1.) could have been caused by the low performance of the hydraulic component. This low performance could be due to improper heat treatment during the rod manufacturing process, which led to low material hardness, embrittlement at temperature, and stress corrosion cracking [14].

Fig. 1. Cracked surface of the piston rod, followed by component failure [14]

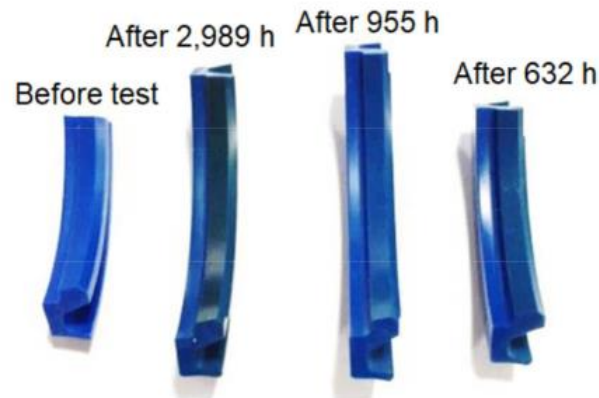
In the work of J. Bae and K.H. Chung [15] three situations of contact between seals and hydraulic cylinders were studied. For the three situations, a hydraulic seal made of a polyurethane elastomer was used as the material pair, and the counter material of the hydraulic cylinder was galvanized stainless steel with chromium. The lubricant used was ISO VG 46 under several conditions, one was a new lubricant, the second was worn for 1000 hours, and the third was the new lubricant in which 1 μm aluminium oxide particles were introduced to accelerate abrasive wear. The first situation was the study of three polyurethane rings obtained from an excavator after being used for 26, 11 and 10 months, during which they operated for 2989, 955 and 632 hours. The lubricant introduced was a new lubricant, but its change at a certain time interval could not be monitored. The hydraulic pressure at which it worked was between 0 and 22 MPa, with a sliding speed from 0 to several hundred mm/s, at a maximum stroke of the pistons of 850 mm in operation. Fig. 2. shows photographs of the polyurethane rings after operation.

Fig. 2. O-rings before testing, after 2989, 955 and 632 hours [15]

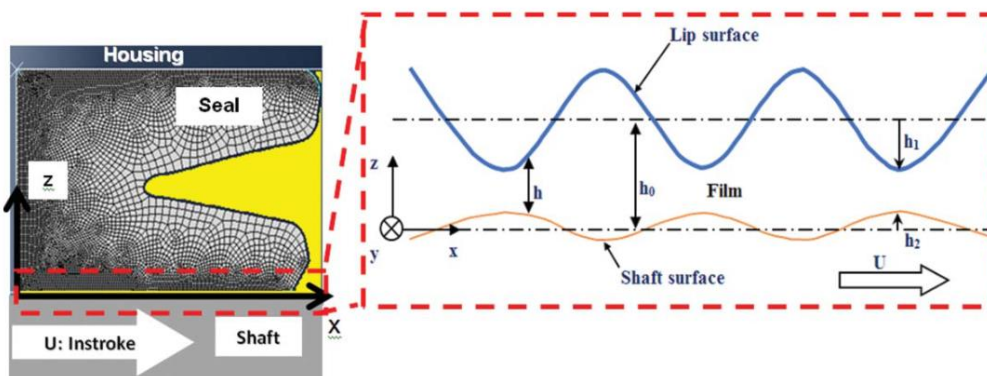
Research has been carried out that analyzed the influence of surface roughness and different lubrication models, so starting from these, the authors of this article have developed a one-dimensional elasto-hydro-dynamic model to analyze the tribological behavior of seals. This model aims to analyze the interaction between the lubricant and the elastic deformation of the seal edge, taking into consideration the roughness of the rod and the seal edge and comparing the results obtained with the inverse hydrodynamic lubrication (IHL) model and with existing experimental data. Fig. 10. highlights the piston rod seal and the sealing area, for which it is desired to determine the hydrodynamic pressure, the distribution of the lubricant film thickness and the friction over the contact width between the two components, the structural analysis of the model where it was necessary to simulate the seal assembly and calculate the static contact pressure distribution.

Fig. 10. U-type seal mounted on the stem [19]

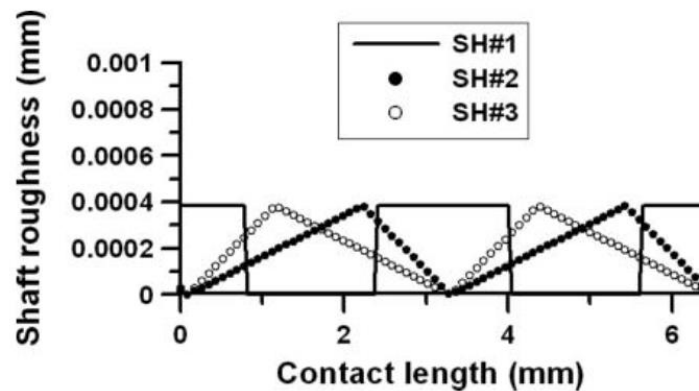
Three types of grooves on the rod surface were tested and compared, shown in Fig. 11., SH#1 with rectangular grooves, SH#2 with asymmetrical grooves inclined towards the fluid pressure side and SH#3 with asymmetrical grooves inclined towards the air pressure side. It was found from the tests that the SH#3 surface with asymmetrical profile contributes to complete lubrication and significantly reduces the friction force compared to other surfaces.

Fig. 11. Profile of the rod grooves [19]

The results of the obtained model were compared with experiments carried out by other researchers, and the difference between the numerical simulations and the experimental data was approximately 7%, thus confirming the accuracy of the model compared to the results obtained with the inverse hydrodynamic lubrication (IHL) model. It was observed that the roughness of the rod significantly influences the friction force and the power loss due to the hydrodynamic pressure generated by the rod's roughness, which increases the thickness of the lubricant film, therefore the roughness must be considered to obtain realistic results. At the same time, it was found that a greater depth of the grooves reduces the friction and power losses in the system, while a higher density can lead to increased friction.
